SERVICE BULLETIN

Subject: Guide Assembly with Small Bore and Improper Bonded O-Ring

Revision: Original Date: Aug 14, 2013 Service Bulletin No: 130814-001 Page 1 of 5

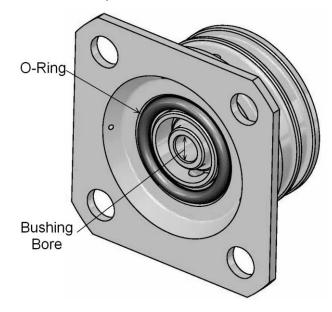
Figure 1, Guide Assy Showing the O-ring and Bushing Bore

As a result of a single customer report, Wencor has confirmed that the Guide Assembly PN 3162808-6WE has a bushing bore that may be slightly undersize and the bonded in O-ring may have an inadequate bond that would allow the O-ring to come out of the groove at assembly or in service.

The bushing bore was manufactured with an ID size of .1570" - .1575" and the required ID size is .1574" - .1579". This allows for the possibility of an undersized condition which will prevent the guide shaft from installing into the bushing bore of the Guide Assembly.

The bonding process to bond the O-ring in the groove of the Guide Assembly may not have been done properly to achieve an acceptable bonded joint. This could possibly allow the O-ring to fall out or be dislodged from the groove.

Verify the bushing bore ID is sized at 0.1574" – 0.1579" as shown in Figure
If the bushing bore ID size is within these limits the Guide Assembly is acceptable. If the bushing bore ID size is outside these limits, the Guide Assembly should be returned to Wencor as described in section 4 of this SB.

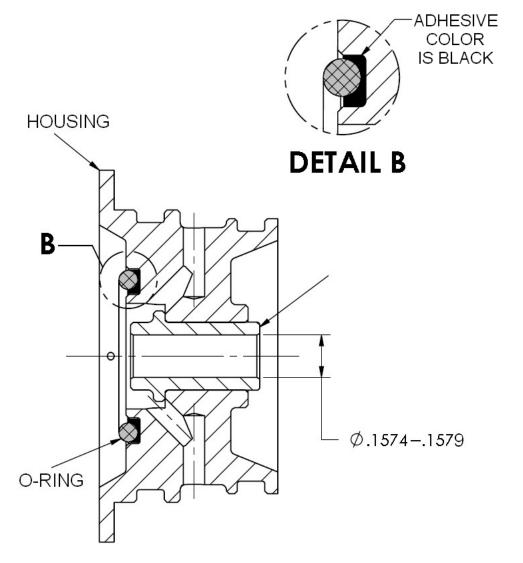
The improper bonding of the O-ring may allow the O-ring to fall out of the groove in the Guide Assembly, or allow portions of the O-ring to break off and fall out of the groove. This will result in downstream bleed air leakage past the O-ring.

II. Verify the bonded O-ring is properly bonded to the Guide Assembly. Using light finger pressure, verify all bonded surfaces of the O-ring are intact (no gaps) and the O-ring will remain in the groove. The adhesive should be visibly present on the ID and OD of the O-ring as shown in Figure 2 with enough adhesive to achieve this requirement. If the O-ring is found to be fully bonded to the Guide Assembly, the bond is acceptable. If the O-ring bond does not meet this criteria, the Guide Assembly should be returned to Wencor as described in section 4 of this SB.

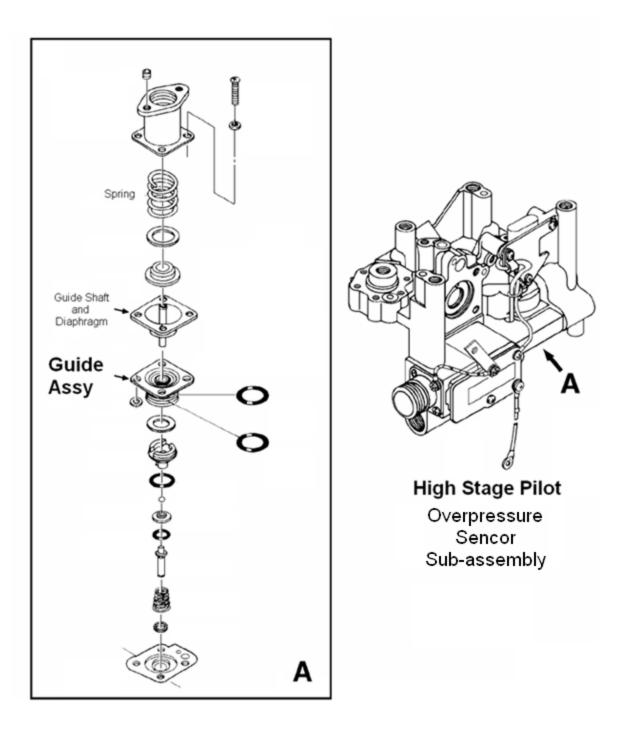
The Guide Assembly is installed in the over-pressure sensor sub-assembly of the NHA High Stage Pilot as shown in Figure 3. The Guide Assembly serves two main purposes: (a) provide a bore to "guide" the guide shaft as it moves in and out through the Guide Assembly bushing and (b) provide a seal to prevent bleed air leakage when the plate on the guide shaft contacts the bonded in-place O-ring.
