# SERVICE INFORMATION LETTER

**Subject:** Center Shaft with damaged edge preventing proper installation.

Service Information Letter No: 130513-001  
Page 1 of 3

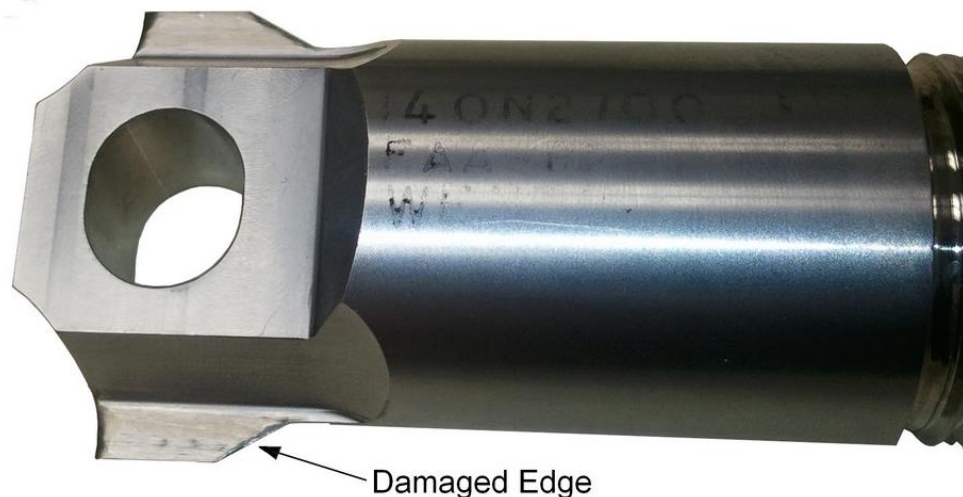
During installation of the Wencor Center Shaft PN 140N2700-5WA, a single customer discovered that an edge was slightly damaged as shown in Figure 1 below, and the damage prevented proper assembly into the NHA.

**Figure 1**, Wencor Center Shaft with Damaged Edge

Any Wencor Center Shaft that is currently uninstalled that has the condition described in this SIL should be returned to Wencor for replacement.

However, any Wencor Center Shaft that is currently installed and in-service that have the condition described in the SIL may remain in service at the discretion of the end user without any change in aircraft safety.

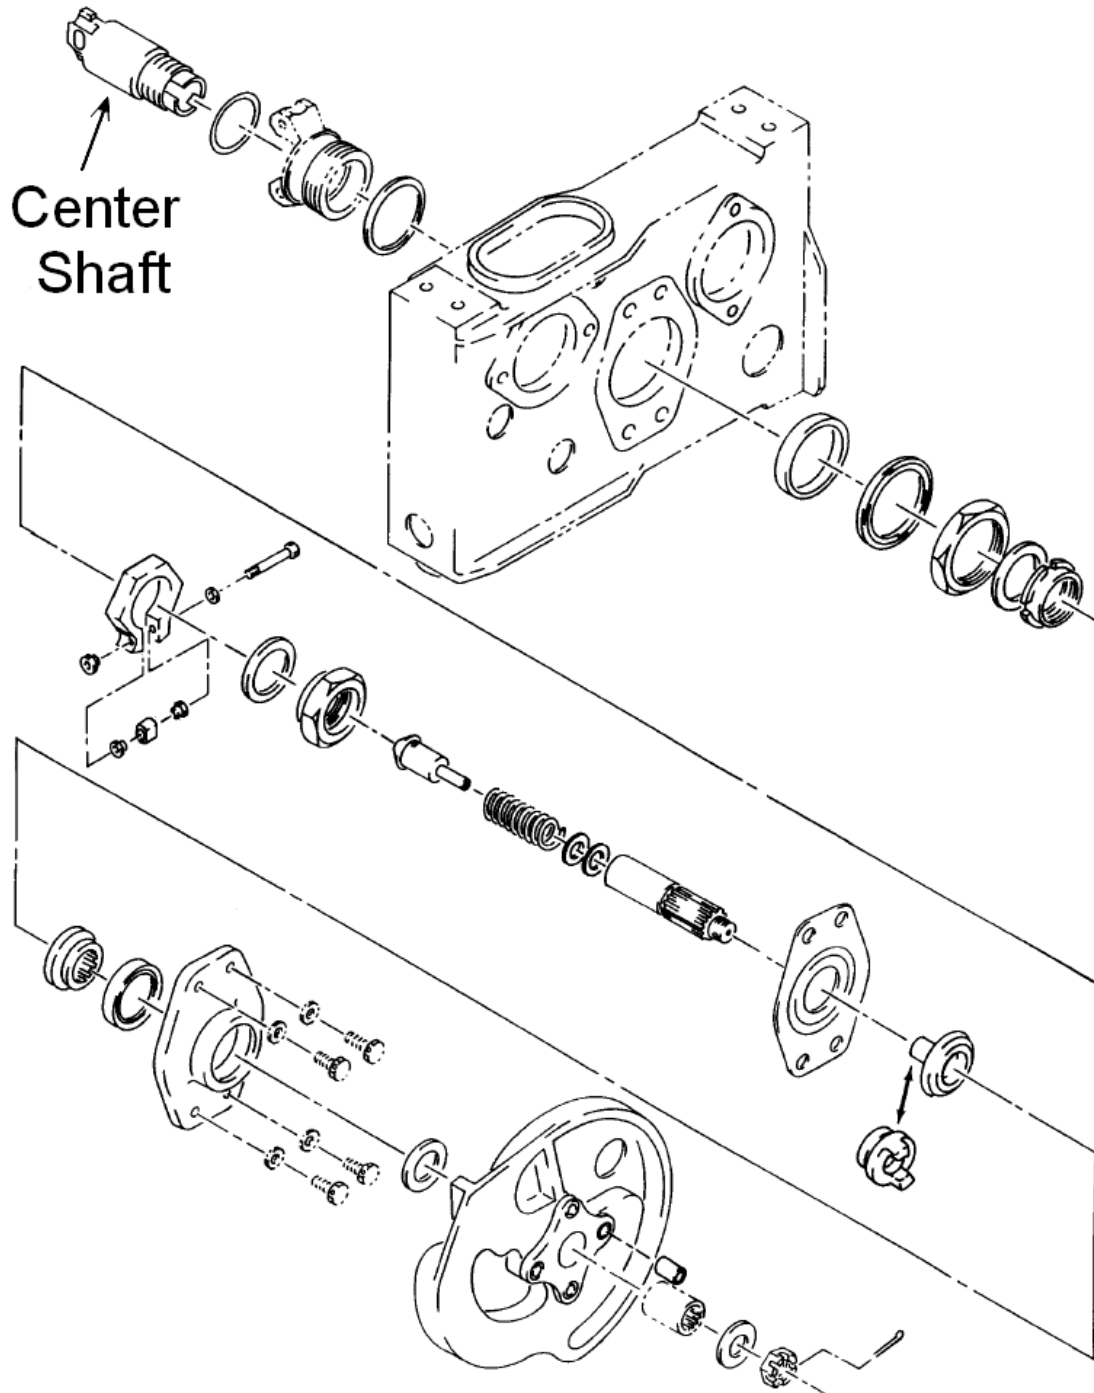
**Figure 2, Exploded View of Center Shaft Installation**

The source or cause of the damaged edge has not been conclusively determined, however the only effect of the damaged edge is displaced material that causes an interference with the mating features on the NHA (see Figure 2 below) thus preventing proper installation.
