# SERVICE INFORMATION LETTER

SIL # 170508-11-6557-5WD

**SUBJECT:** It has been determined that some Wencor PMA PN 11-6557-5( )WD Bezel Assemblies shipped prior to February 27, 2017 may be defective. In particular the Lens may pop out during assembly or when impacted with a force less than 10 lbs.

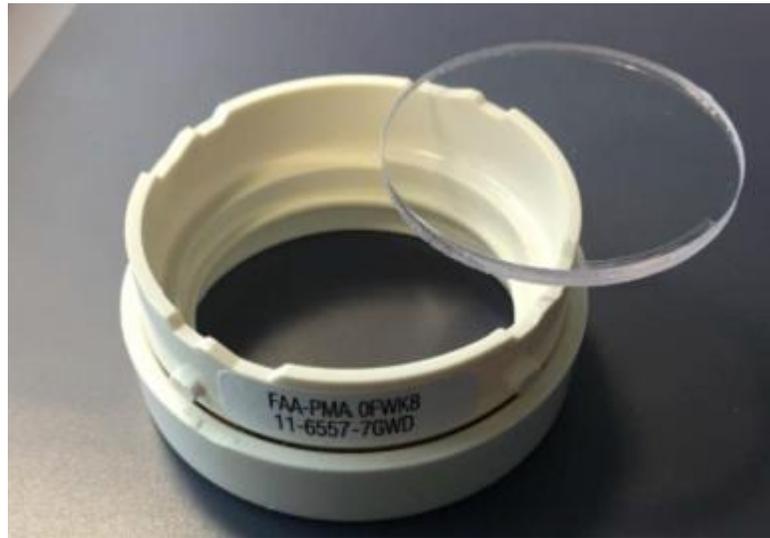
During an investigation for a similar part it was determined that some PMA part number 11-6557-5( )WD Bezels do not meet drawing requirements regarding workmanship with respect to adhesive application and Lens retention.

Lens detachment has been reported by one customer on a similar part. The defect was detected during installation. There have been no customer reports of this defect occurring with respect to the subject part, however some parts in stock were determined to be defective.

Figure 1. Defective Part from Customer– Lens Separated During Installation

Any Wencor PN 11-6557-5( )WD Bezel Assemblies that are currently in service may remain in service at the discretion of the operator.

Any Wencor PN 11-6557-5( )WD Bezel Assemblies that have not been installed may be returned to Wencor for credit or replacement as described in Section 4 below.
