SERVICE INFORMATION LETTER

Subject: Installation Recommendations for Wencor Tubular Rivet PN 800162WE, installed in the JT8D Engine 7th Stage High Pressure Compressor (HPC) Disk.

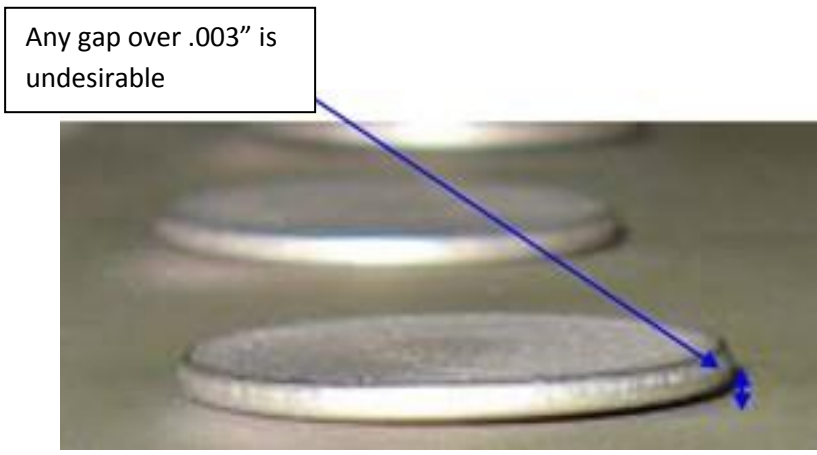
Figure 3, Showing Undesirable Gap Under Rivet Head

As shown below in Figure 3, examination of some rivets still installed in the disk showed that the rivet heads were not setting flat or parallel against the blade pin or disk surface after installation. This results in a gap between the underside of the rivet head and top side of the blade pin. Wencor considers any gap that is larger than .003" a contributing factor that could cause stress in the rivet radius that could contribute to head liberation.

The gap shown in Figure 3, results in uneven contact between the underside of the rivet head and the blade pin. The uneven contact is shown by witness marks on the underside of the rivet head as shown below in Figure 4. The uneven contact creates an undesirable bending stress at the rivet radius which could contribute to head liberation.

After the rivet flaring process, during step 2 of task 72-36-02-44-003-002 (JT8D-1/17 EMM for PN 481672) or in task 72-36-02-44-003-003 (JT8D-209/219 for PN 773128), verify that the gap between the rivet head and the blade pin as shown in Figure 8 does not exceed .003”.

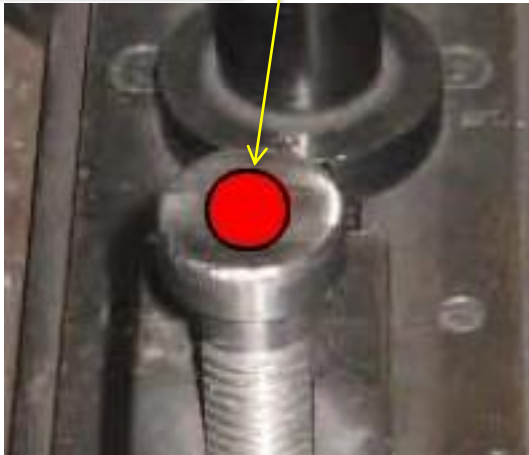
Simulated Rivet Head
Correct Position, Fully
Supported By Mandrel

During the rivet flaring process, when the rivet is installed into the 7th stage disk and the disk is set upon the disk support tool (PWA 33565) as shown below in Figure 6 and described in step 1 of task 72-36-02-44-003-002 (JT8D-1/17 EMM for PN 481672) or in task 72-36-02-44-003-003 (JT8D-209/219 for PN 773128). Prior to flaring the rivet, the rivet head must be fully supported by the mandrel as shown in Figures 7 & 7a.

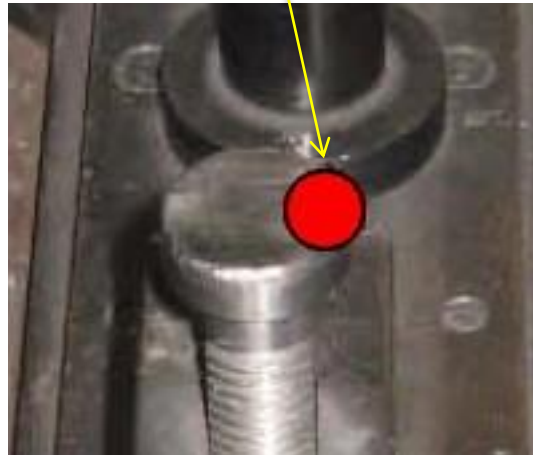
Simulated Rivet Head
Incorrect Position, Only Partly
Supported by Mandrel
